An Assessment of Potential Material Candidates for the “Flight Day 2” Radar Object Observed during the NASA Mission STS-107

Air Force Research Laboratory
Technical Note
AFRL-SNS-2003-001

An Assessment of Potential Material Candidates
for the "Flight Day 2" Radar Object Observed
During the NASA Mission STS-107 (Columbia)

Final Summary Report

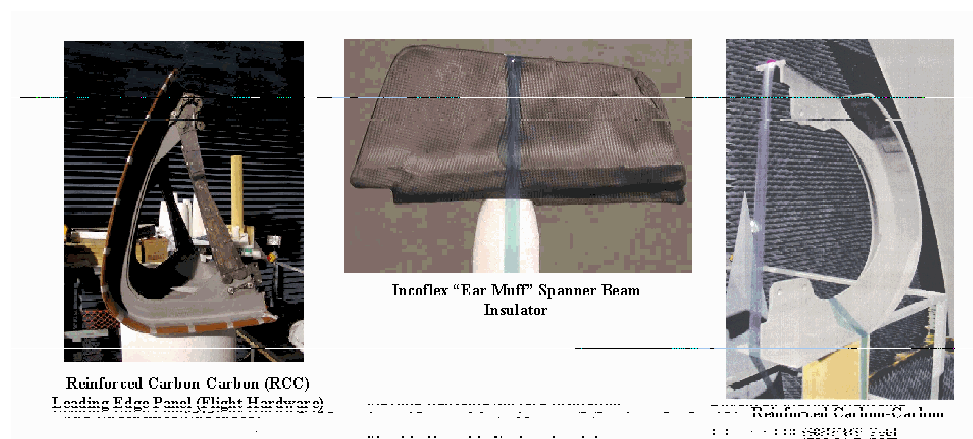
Figure 5 – Elements of the Reinforced Carbon Carbon (RCC) Leading Edge Thermal Protection System (TPS)

The reinforced carbon-carbon (RCC) materials consist primarily of leading edge panels with Tee-Seals between adjacent RCC panels. Figure 5 below shows an entire RCC panel with the Tee-Seal clearly visible on the end. The rightmost picture of Figure 5 is the tee seal alone without any edge attached. The center picture is called the Incoflex spanner beam insulation piece, though NASA engineers commonly call it the “ear muff” seal. This insulation is typical of that found in the wing leading edge cavity and is used to protect the structure from high temperatures during reentry. Taken together, Figures 3, 4, and 5 comprise the suite of materials of the TPS system.

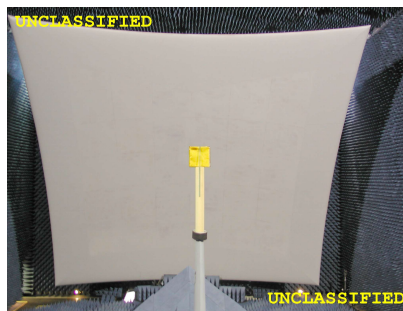
Figure 10 – ML-004 TPS Blanket in the AFRL ACR for UHF RCS Testing

removed from the facility during the actual RCS measurement. The sample, as mounted in the range, can be seen in Figure 10 below. For scale purposes, the sample in Figure 10 is roughly 30 cm (12 inches) on a side. The reflector is 19 m forward, and its dimensions are roughly 14 m x 14 m.
